REPORT ON ROUTINE THOROUGH EXAMINATION OF LOCAL EXHAUST VENTILATION (LEV) PLANT

MERVYN LAMBERT PLANT LIMITED

FEBRUARY 2025

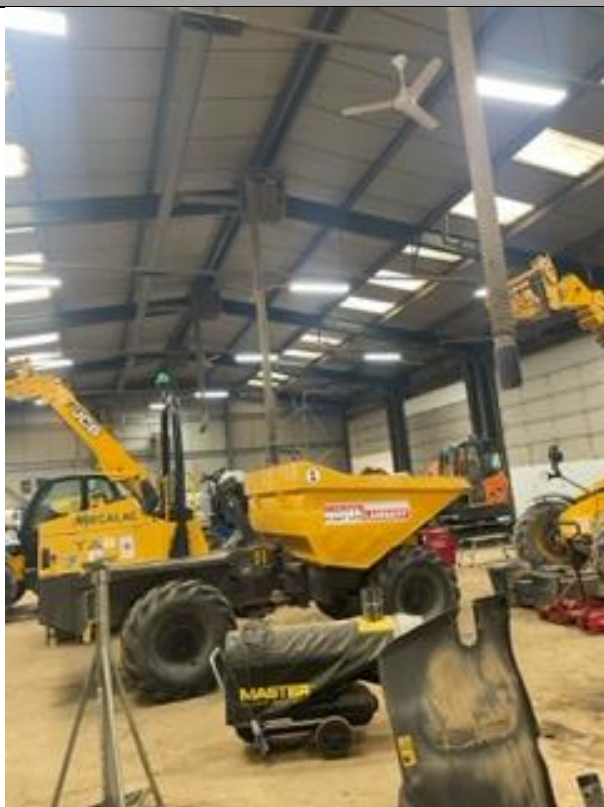
LEV1

Extraction Points	
Conditions at Time of Test	Operational, LEV tested as found.
Intended Performance of Plant	The recommended capture velocity to control the fume generated is 0.5 m/s. Duct (transport) velocity should be approx. 10 m/s.
Actual Performance of Plant	The capture and face velocities achieved the recommended value.

Fan / Air mover			
Type:	Centrifugal	Make:	Plymovent
Motor Rating: (Hz)	50	Drive type	Direct
Motor Voltage: (Volts)	400	Motor Power:	2.2kw
Motor Direction:	Anti – clockwise	Direction Confirmed:	Yes
Impeller type:	Backwards Curved	General Condition of Fan:	Good
Make Up Air Type:	General Building Ventilation	Adequate Make Up Air	Yes

<u>Duct Specification</u>			
Duct Type:	Spiralised Galvanized Steel	Duct Temperature	15.3
External Condition of Duct	Good	Barometric Pressure:	1013mb
Inspection Hatches Fitted	NO	Damper Settings:	Control Dampers closed at Equipment
Internal Examination	BOREScope

<u>Stack / Termination</u>			
Stack Type:	Horizontal	Stack Height:	At the roof line
Condition of Stack:	Good		
Weatherproof Termination:	Steel Cowl	Damper Settings:	Control Dampers closed at Equipment
Stack Height Sufficient to Ensure Full Dispersion:		Yes

<u>Defects & Recommendations</u>					
LEV Examiner			Employer's Use		
Item in LEV System	Action Required	Priority*	Person to Action	Target Date	Date Completed
LEV	Report to be filed in Logbook and held for 5 years to comply with COSHH 2002.	4			
LEV	Place Signage on equipment to advise user of the need for PPE to be worn at all times	1			
TP 1 & 2	Holes in the Flex. .	4			
<i>*Priority – 1=high, 2= normal, 3=Routine, 4= Awareness. All Critical Defects are shaded in RED</i>

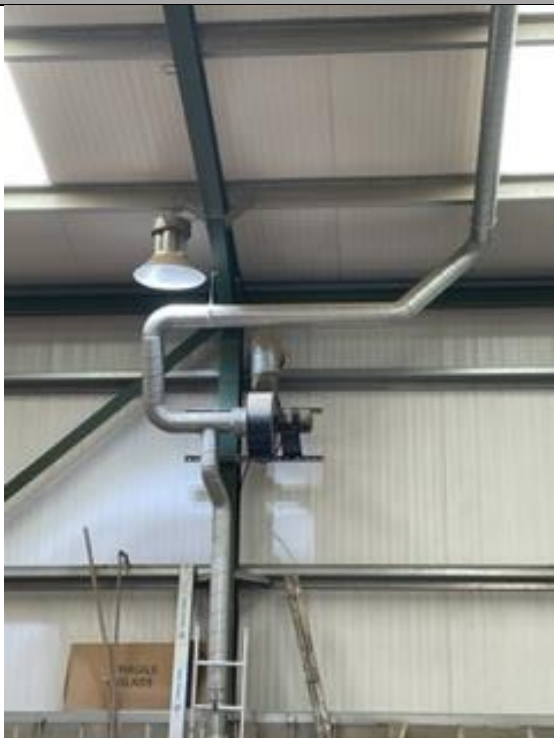
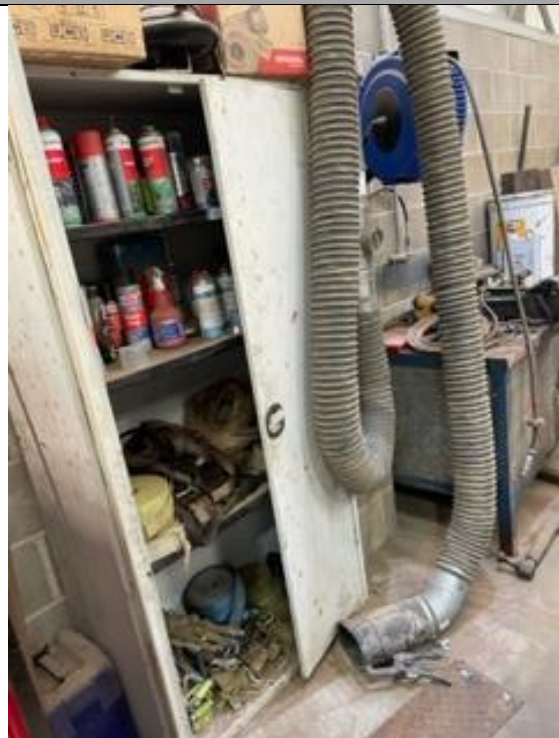
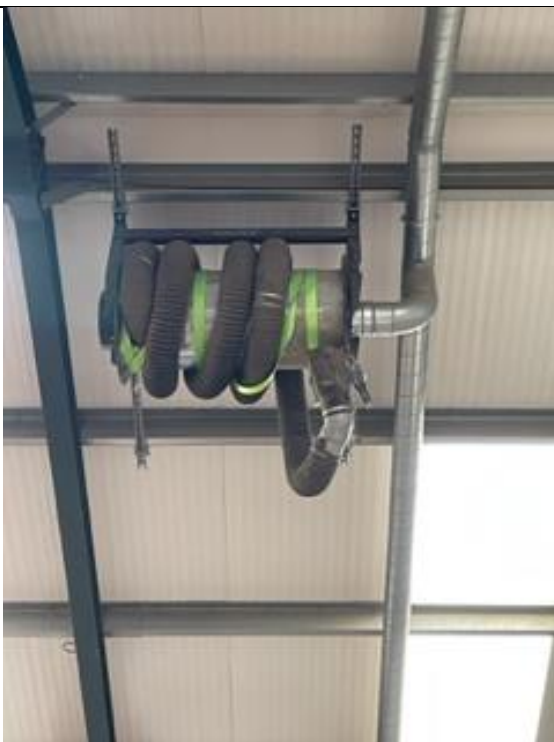
LEV2

Extraction Points	
Conditions at Time of Test	Operational, LEV tested as found.
Intended Performance of Plant	The recommended capture velocity to control the fume generated is 0.5 m/s. Duct (transport) velocity should be approx. 10 m/s.
Actual Performance of Plant	The capture and face velocities achieved the recommended value.

Fan / Air mover			
Type:	Centrifugal	Make:	Movex
Motor Rating: (Hz)	50	Drive type	Direct
Motor Voltage: (Volts)	400	Motor Power:	0.75kw
Motor Direction:	Anti – clockwise	Direction Confirmed:	Y – Non-Contact indicator
Impeller type:	Backwards Curved	General Condition of Fan:	Good
Make Up Air Type:	General Building Ventilation	Adequate Make Up Air	Yes

<u>Duct Specification</u>			
Duct Type:	Spiralised Galvanized Steel	Duct Temperature	16.4
External Condition of Duct	Good	Barometric Pressure:	1013mb
Inspection Hatches Fitted	NO	Damper Settings:	Control Dampers closed at Equipment
Internal Examination	BOREScope

<u>Stack / Termination</u>			
Stack Type:	Vertical	Stack Height:	Above the roof line
Condition of Stack:	Good		
Weatherproof Termination:	Jet Cowl	Damper Settings:	Control Dampers closed at Equipment
Stack Height Sufficient to Ensure Full Dispersion:		Yes

LEV Examiner			Employer's Use		
Item in LEV System	Action Required	Priority*	Person to Action	Target Date	Date Completed
LEV	Report to be filed in Logbook and held for 5 years to comply with COSHH 2002.	4			
LEV	Place Signage on equipment to advise user of the need for PPE to be worn at all times	1			
Test Point 2	Hose reel ratchet is stuck at roof level requires fixing.	1

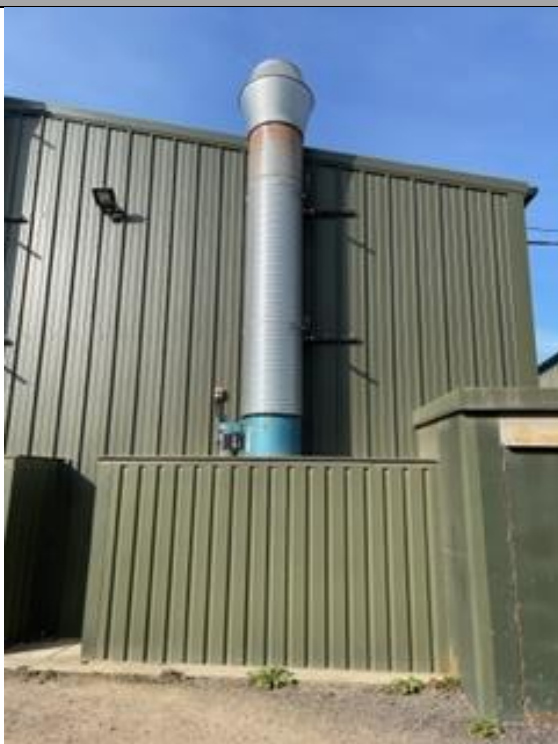
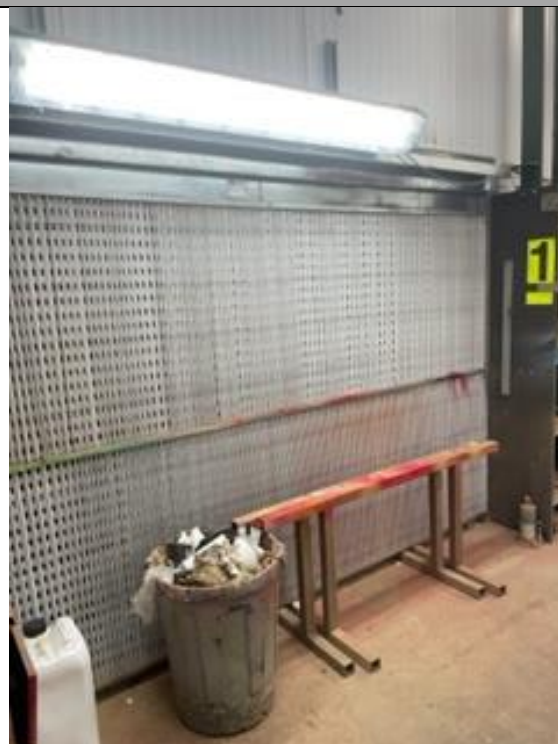
LEV3

Extraction Points	
Conditions at Time of Test	Operational, LEV tested as found.
Intended Performance of Plant	The recommended capture velocity to control the fume generated is 0.5 m/s. Duct (transport) velocity should be approx. 10 m/s.
Actual Performance of Plant	The capture and face velocities achieved the recommended value.

Fan / Air mover			
Type:	Axial	Make:	
Motor Rating: (Hz)	50	Drive type	Belt
Motor Voltage: (Volts)	400	Motor Speed / Power:	1440 / 3kw
Motor Direction:	Anti – clockwise	Direction Confirmed:	Y – Non-Contact indicator
Impeller type:	Axial	General Condition of Fan:	Good
Make Up Air Type:	General Building Ventilation	Adequate Make Up Air	Yes

<u>Filter / Collector</u>			
Air exhausted to workplace:		No – to atmosphere	
Primary Filter Type:	Insert	Make:	
Filter Medium:	Pleated Paper	Model:	
Secondary Filter Type:		Make:	
Filter Medium:		Model:	
Condition of Filters:	Good		
Evidence of Contaminant Breakthrough:	None		
Cleaning Mechanism Operating Correctly:	On Filter Change		
Condition of all Seals on Filter Unit:	Good

<u>Duct Specification</u>			
Duct Type:	Spiralised Galvanized Steel	Duct Temperature	
External Condition of Duct	Good	Barometric Pressure:	1013mb
Inspection Hatches Fitted	NO	Damper Settings:	Control Dampers closed at Equipment
Internal Examination	VISUAL

<u>Stack / Termination</u>			
Stack Type:	Vertical	Stack Height:	Above apex of roof
Condition of Stack:	Good		
Weatherproof Termination:	Jet Cowl	Damper Settings:	Control Dampers closed at Equipment
Stack Height Sufficient to Ensure Full Dispersion:	Yes

Defects & Recommendations					
LEV Examiner			Employer's Use		
Item in LEV System	Action Required	Priority*	Person to Action	Target Date	Date Completed
LEV	Report to be filed in Logbook and held for 5 years to comply with COSHH 2002.	4			
LEV	Place Signage on equipment to advise user of the need for PPE to be worn at all times	1			
<i>*Priority – 1=high, 2= normal, 3=Routine, 4= Awareness. All Critical Defects are shaded in RED</i>

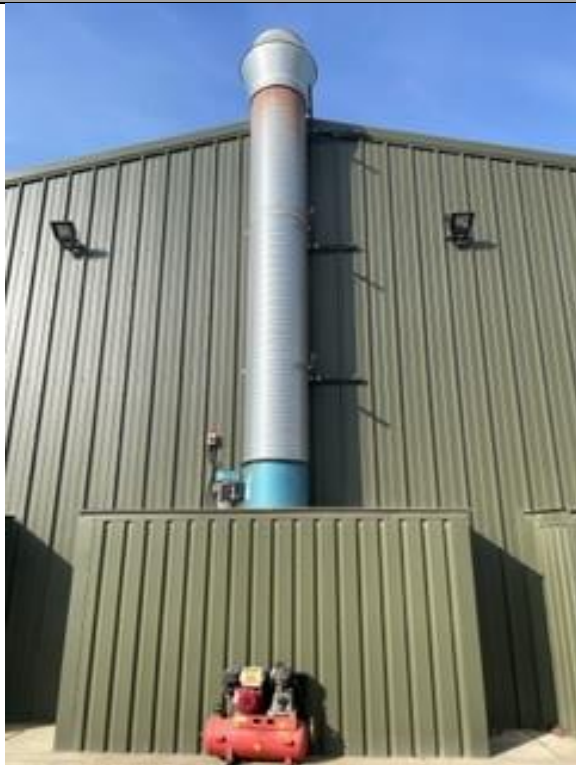
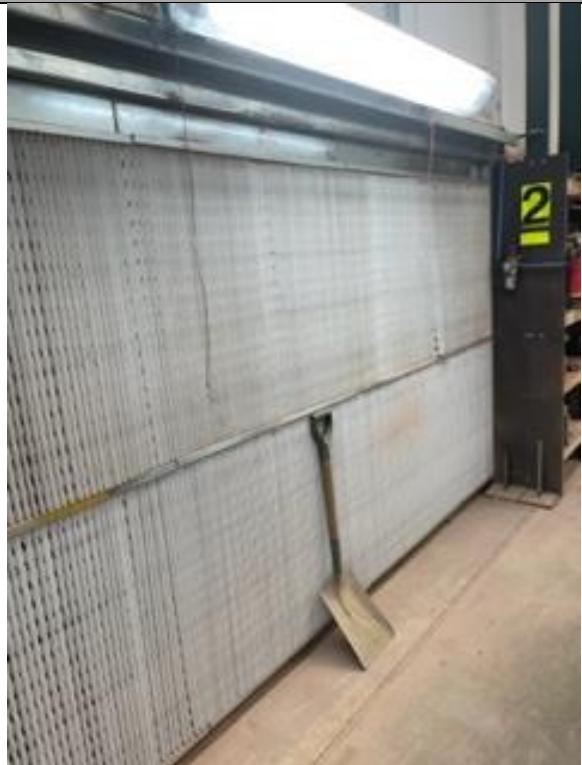
LEV4

Extraction Points	
Conditions at Time of Test	Operational, LEV tested as found.
Intended Performance of Plant	The recommended capture velocity to control the fume generated is 0.5 m/s. Duct (transport) velocity should be approx. 10 m/s.
Actual Performance of Plant	The capture and face velocities achieved the recommended value.

Fan / Air mover			
Type:	Axial	Make:	
Motor Rating: (Hz)	50	Drive type	Belt
Motor Voltage: (Volts)	400	Motor Speed / Power:	1440 / 3kw
Motor Direction:	Anti – clockwise	Direction Confirmed:	Y – Non-Contact indicator
Impeller type:	Axial	General Condition of Fan:	Good
Make Up Air Type:	General Building Ventilation	Adequate Make Up Air	Yes

<u>Filter / Collector</u>			
Air exhausted to workplace:		No – to atmosphere	
Primary Filter Type:	Insert	Make:	
Filter Medium:	Pleated Paper	Model:	
Secondary Filter Type:		Make:	
Filter Medium:		Model:	
Condition of Filters:	Good		
Evidence of Contaminant Breakthrough:	None		
Cleaning Mechanism Operating Correctly:	On Filter Change		
Condition of all Seals on Filter Unit:	Good

<u>Duct Specification</u>			
Duct Type:	Spiralised Galvanized Steel	Duct Temperature	
External Condition of Duct	Good	Barometric Pressure:	1013mb
Inspection Hatches Fitted	NO	Damper Settings:	Control Dampers closed at Equipment
Internal Examination	VISUAL

<u>Stack / Termination</u>			
Stack Type:	Vertical	Stack Height:	Above apex of roof
Condition of Stack:	Good		
Weatherproof Termination:	Jet Cowl	Damper Settings:	Control Dampers closed at Equipment
Stack Height Sufficient to Ensure Full Dispersion:	Yes

Defects & Recommendations					
LEV Examiner			Employer's Use		
Item in LEV System	Action Required	Priority*	Person to Action	Target Date	Date Completed
LEV	Report to be filed in Logbook and held for 5 years to comply with COSHH 2002.	4			
LEV	Place Signage on equipment to advise user of the need for PPE to be worn at all times	1			
<i>*Priority – 1=high, 2= normal, 3=Routine, 4= Awareness. All Critical Defects are shaded in RED</i>

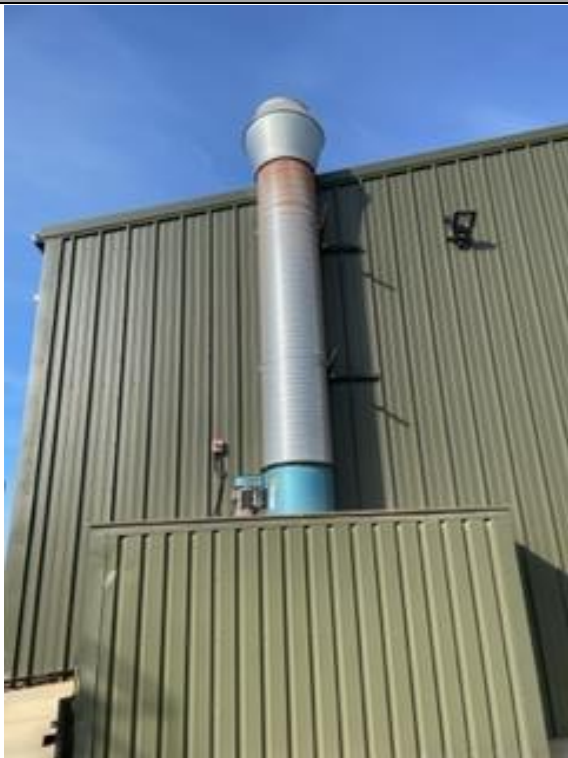
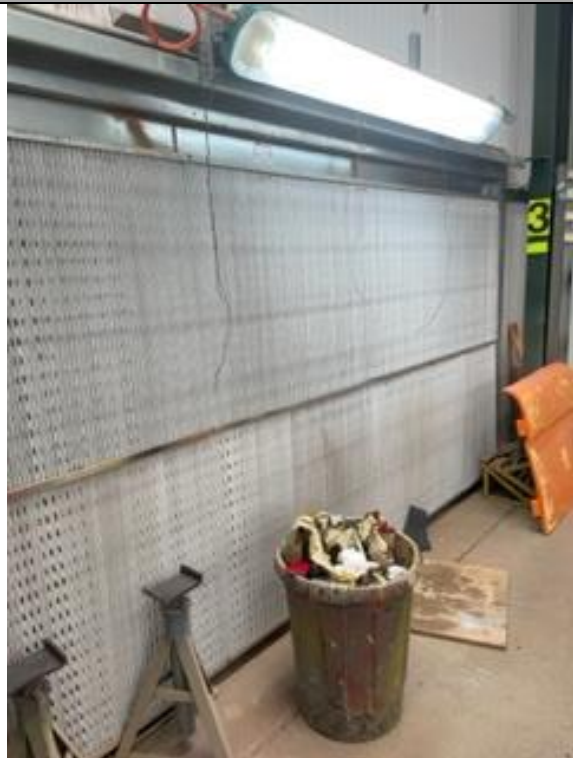
LEV5

Extraction Points	
Conditions at Time of Test	Operational, LEV tested as found.
Intended Performance of Plant	The recommended capture velocity to control the fume generated is 0.5 m/s. Duct (transport) velocity should be approx. 10 m/s.
Actual Performance of Plant	The capture and face velocities achieved the recommended value.

Fan / Air mover			
Type:	Axial	Make:	
Motor Rating: (Hz)	50	Drive type	Belt
Motor Voltage: (Volts)	400	Motor Speed / Power:	1440 / 3kw
Motor Direction:	Anti – clockwise	Direction Confirmed:	Y – Non-Contact indicator
Impeller type:	Axial	General Condition of Fan:	Good
Make Up Air Type:	General Building Ventilation	Adequate Make Up Air	Yes

<u>Filter / Collector</u>			
Air exhausted to workplace:		No – to atmosphere	
Primary Filter Type:	Insert	Make:	
Filter Medium:	Pleated Paper	Model:	
Secondary Filter Type:		Make:	
Filter Medium:		Model:	
Condition of Filters:	Good		
Evidence of Contaminant Breakthrough:	None		
Cleaning Mechanism Operating Correctly:	On Filter Change		
Condition of all Seals on Filter Unit:	Good

<u>Duct Specification</u>			
Duct Type:	Spiralised Galvanized Steel	Duct Temperature	
External Condition of Duct	Good	Barometric Pressure:	1013mb
Inspection Hatches Fitted	NO	Damper Settings:	Control Dampers closed at Equipment
Internal Examination	VISUAL

<u>Stack / Termination</u>			
Stack Type:	Vertical	Stack Height:	Above apex of roof
Condition of Stack:	Good		
Weatherproof Termination:	Jet Cowl	Damper Settings:	Control Dampers closed at Equipment
Stack Height Sufficient to Ensure Full Dispersion:	Yes

Defects & Recommendations					
LEV Examiner			Employer's Use		
Item in LEV System	Action Required	Priority*	Person to Action	Target Date	Date Completed
LEV	Report to be filed in Logbook and held for 5 years to comply with COSHH 2002.	4			
LEV	Place Signage on equipment to advise user of the need for PPE to be worn at all times	1			
<i>*Priority – 1=high, 2= normal, 3=Routine, 4= Awareness. All Critical Defects are shaded in RED</i>

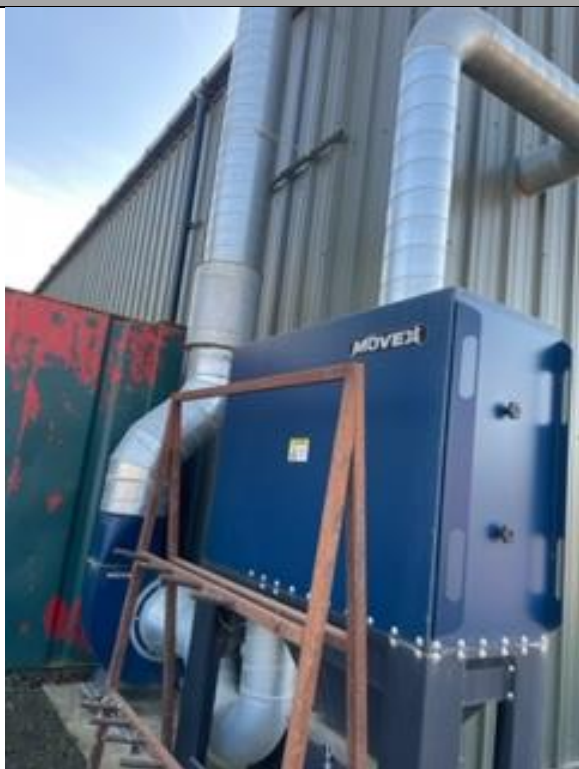
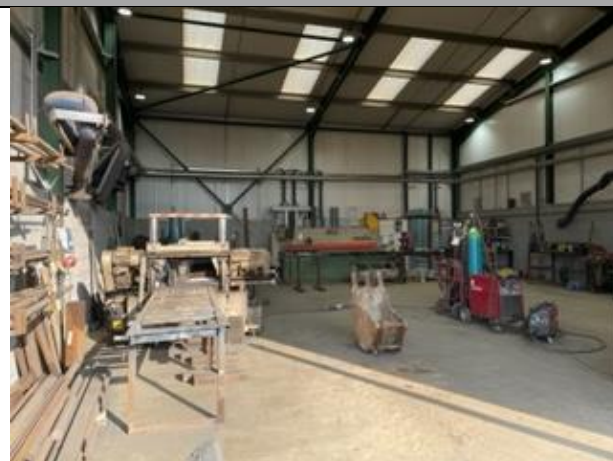
LEV7

Extraction Points	
Conditions at Time of Test	Operational, LEV tested as found.
Intended Performance of Plant	The recommended capture velocity to control the fume generated is 0.5 m/s. Duct (transport) velocity should be approx. 10 m/s.
Actual Performance of Plant	The capture and face velocities achieved the recommended value.

Hoods Suitable for Substance / Benchmark:	YES	Hood Flow Indicators Fitted:	NO
Hood Pass/Fail Labels Fitted:	YES	Captor Hood "Effective Distance Labels" Fitted	NA
Were Operators Working at time of TExT	YES	Are Hood being Used in the Correct and Intended Manor	YES
Comments on operator usage	Hoods being used in the correct manor as per site training, this is in line with HSE guidelines. With correct PPE for the process.
