REPORT ON ROUTINE THOROUGH EXAMINATION OF LOCAL EXHAUST VENTILATION (LEV) PLANT

MERVYN LAMBERT PLANT LIMITED

FEBRUARY 2025

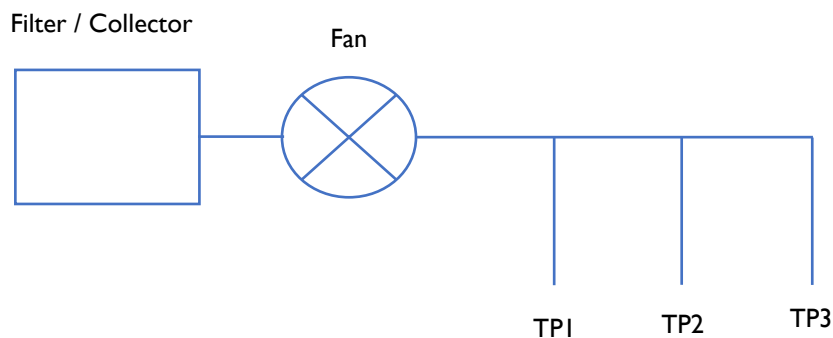
LEV Diagram

Quantitative Results								REF: LEV2	
Measurement Point No.	Description	Hood			Duct			Capture Distance	
		Hood Dimensions (m)	Face Velocity (m/s)	Volume Flow (m³/s)	Duct Dimensions (m)	Static Pressure (Pa)	Duct Velocity (m/s)	Capture Velocity @ 1 m	Confirmed with Qualitative Test
TP1	Oval Hood	0.100 x 0.200	9.39	0.148	0.150	-112	18.4		Y – Dust Lamp
TP2	Oval Hood UNTESTED Mechanical Issue	0.100 x 0.200			0.150				
TP3	Oval Hood	0.100 x 0.200	21.65	0.433	0.150	-640	24.5		Y – Dust Lamp

LEV Examiner			Employer's Use		
Item in LEV System	Action Required	Priority*	Person to Action	Target Date	Date Completed
LEV	Report to be filed in Logbook and held for 5 years to comply with COSHH 2002.	4			
LEV	Place Signage on equipment to advise user of the need for PPE to be worn at all times	1			
Test Point 2	Hose reel ratchet is stuck at roof level requires fixing.	1
